Date:	04/01/2022
Invoice:	2022.10
Client:	
Address:	
Phone:	
Email:	
ETA:	03/25/2022

## Japanned Tray Treatment Report 31" l x 25" w x 1.75" h

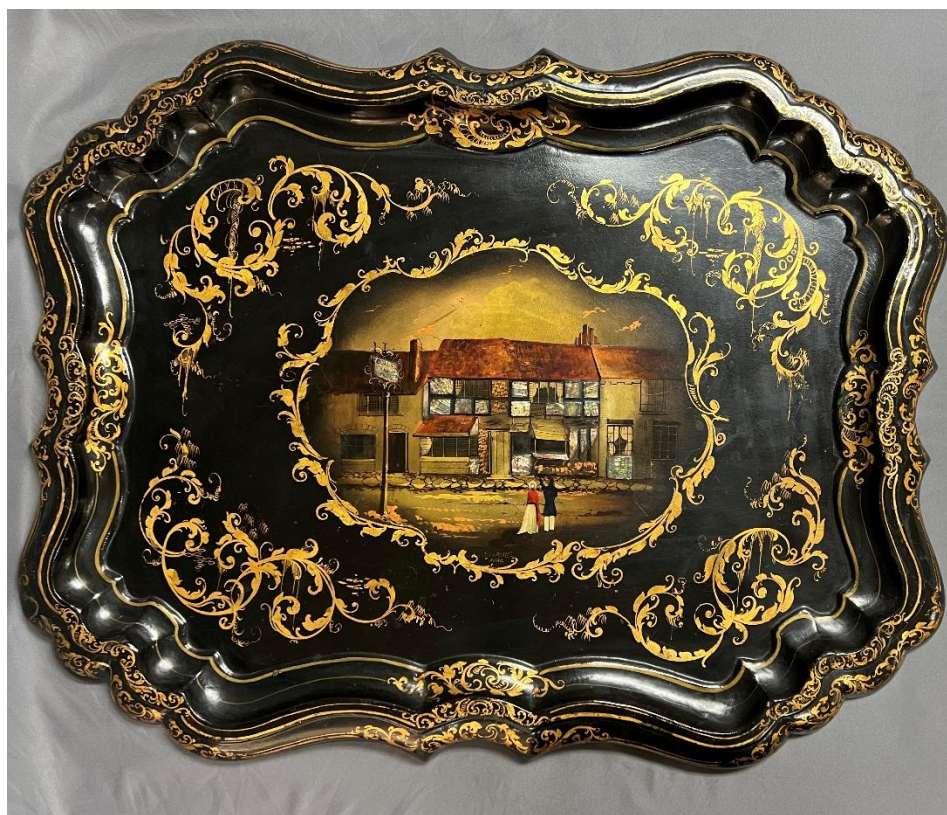
Figure 1 – Japanned Tray after treatment

The tray was consolidated with a 15% solution of Acryloid B-72 in acetone and applied to the edges with a brush and allowed to cure. The pieces were reconstructed with a 50% solution of Acryloid B-72 in acetone. Some pieces were held with medical tape until dry. The tape was removed. During reconstruction, it was discovered that the areas where the tray had broken were also the thinnest areas of the papier- mâché, in some cases as thin as 2 mm. In these areas, there was almost no paper present and the lacquer provided most of the structural support. This could explain why the tray broke in the same areas on either side. The paper sheared in a lateral direction, most likely due to weakness in the paper substrate from acid.

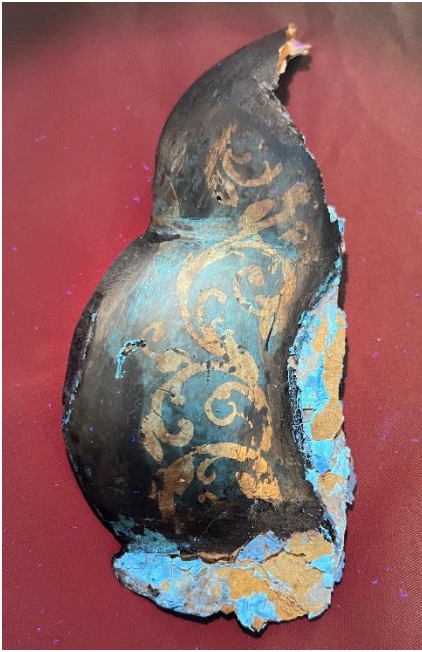
Figure 2 - Detail of old adhesive (fluorescent blue) under UV light

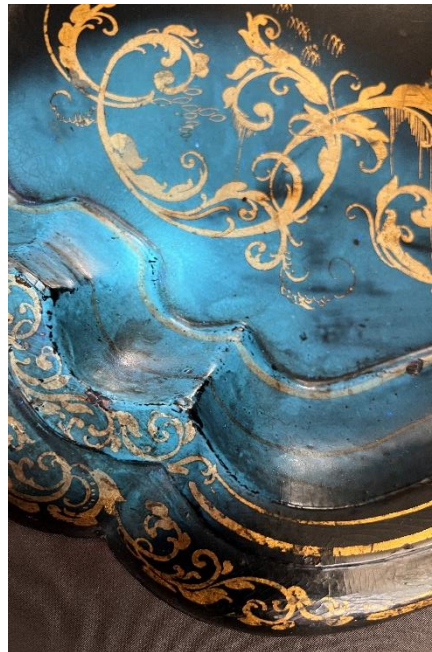
Figure 3 - Detail coating (fluorescent blue) under UV light

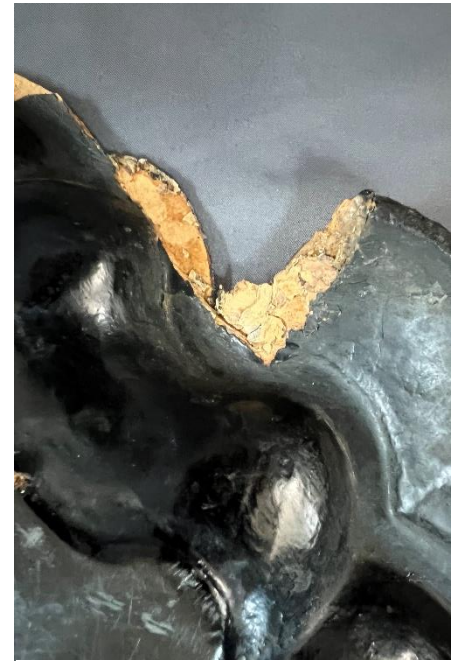
The tray is made of papier-mâché that has been pressed into a mold and a black japanned surface has been applied. A painted scene with inlaid mother of pearl adorns the center with gold painted scrollwork around the front surface. The tray has large breaks at the proper left and right side. The proper right side showed significant previous repair and old adhesive. The front has been lacquered with an unknown substance, but the back is clear. There is a partial sticker on the back with identification information and some losses to the back and remaining edges of the tray.

Figure 4 - Detail of loss to one edge and old repair

The locations of most of the fragments were found, but there was a great deal of loss at the break edges to the front surface of the tray while the thicker scalloped edges fit together and provided stability. There were holes along the thin break edge. It was determined that the breaks should be reinforced, and the holes should be filled with layers of paper. In recesses, thin layers of Japanese kozo kashmir tissue paper was cut to size and laid into the fills. A brush with a 25% solution of Acryloid B-72 in acetone was brushed onto the surface of the paper, soaking through and adhering it to the tray. In areas where there were holes, a layer of kozo kashmir was cut slightly larger than the hole, soaked in the 25% solution of Acryloid B-72 and acetone, and placed over the hole from the back of the tray. These patches were allowed to dry and provided a support by which more layers of the kozo kashmir soaked in the Acryloid B-72 solution could be pressed into the holes. In areas where the substrate was heavier, layers of thicker kozo paper with the solution were inserted from the front of the tray. The layers were added until they reached just below the surface level of the front of the tray. On the back,

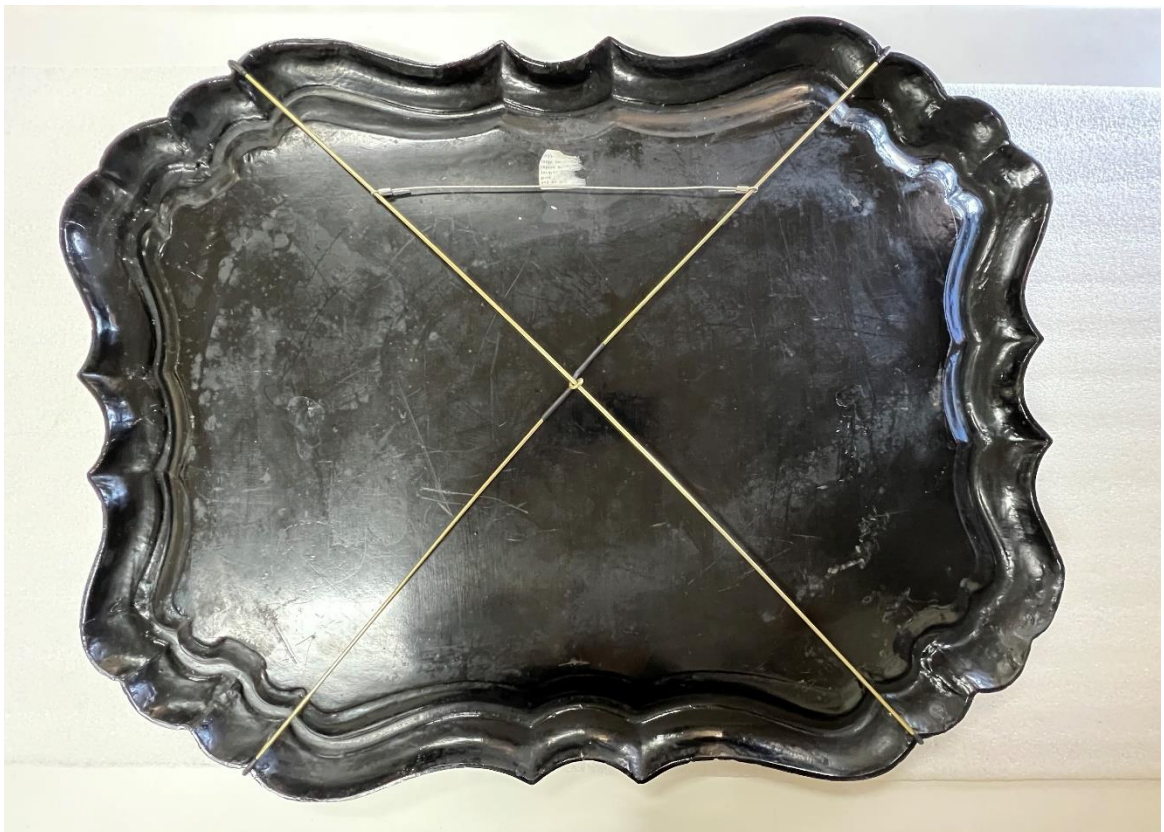
Figure 5 - Custom hanging mechanism

A hanging mechanism was made using 1/8” solid brass rod. The pieces were assembled in an “X” pattern, wrapping the ends around scallops that had not been broken. A loop in the brass rod at the back provided stability, where the other rod passes through, and a 75 lb. wire hanger was added at the top.
