Meissen Clock: 11.5”h x 6.25”w x 4”d

CONDITION REPORT

TREATMENT REPORT

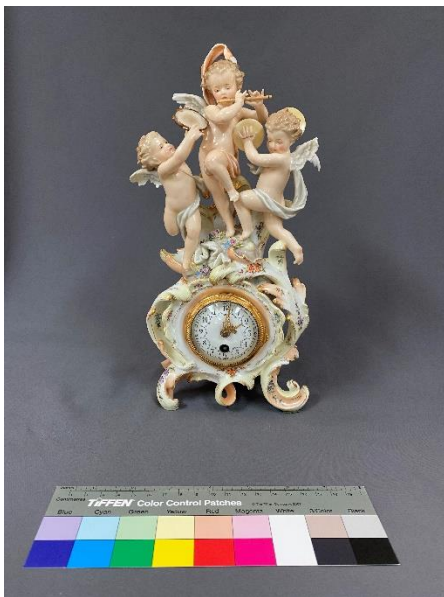
Figure 1 - Clock before treatment

The clock is in overall good condition (Figure 1). There is slight dust throughout and in the recesses. A piece of ribbon is broken from the top of the cherub’s head (Figure 2). The same cherub is also missing the proper left wing (Figure 3). The clock face has a crack in the enamel extending from the 12 down to near the 4 (Figure 4). The cherub on the right has had extensive repair to the lower wing which is missing (Figure 5). UV illumination shows the extent of the old repair on the wing (Figure 6). It is unknown if the clockworks function, winding was not attempted. The brass door has tarnished fingerprints and grime around the edges. The Meissen sword symbol is on the front proper right leg.

It is recommended that the clock be dusted to remove surface dirt. It would be best to attempt to secure the enamel on the clock face to prevent further cracking. The wings and ribbon could be fabricated. The fingerprints could be removed from the door and polished to prevent further etching of the surface. Due to the age and decorative nature of the object, it is not recommended to run the clock and is not addressed in this treatment.

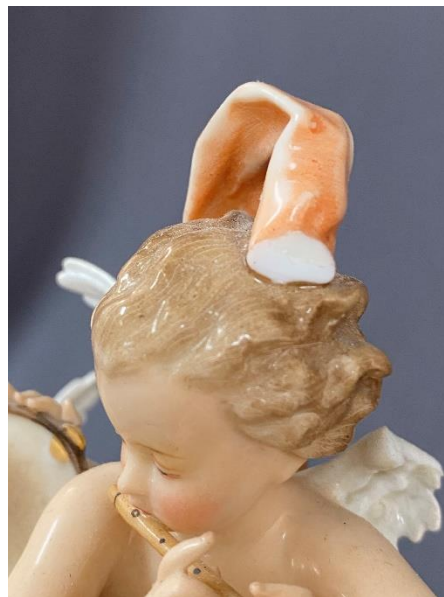
Figure 2 – Detail of broken ribbon

The mold was removed, and excess adhesive was removed with a scalpel. The edge where the fabrication meets the wing was refined with glass paper⁵. Because the fabrication went smoother than expected and time allowed, the same mold was filled with another mixture of Epotek 301 and placed over the lower cherub's wing and refined once dry. The wings and ribbon were inpainted using Golden Acrylic Paints⁶, Acrysol WS-24⁷, and distilled water.

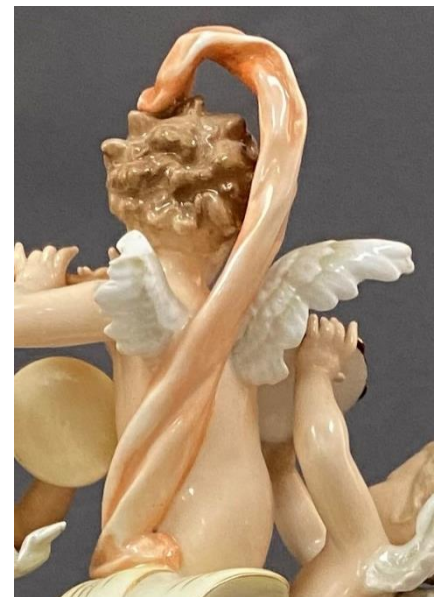
Figure 3 - Detail of broken wing

The clock was tested for solvent sensitivity. None of the decorative elements reacted to the solvents, thus the old repair was removed with a scalpel and cotton swabs dipped in acetone. A mold was taken from another right-side wing using Alumilite Moldputty¹ and allowed to cure for 24 hours. A mixture of Epotek 301² epoxy was mixed with fumed silica³ and powdered pigments⁴ to match the translucency and color of the angel wing. The mold was then placed onto the broken wing of the top angel. Per the client's request, the end of the ribbon was rounded off with a thicker mixture of the same components and shaped with a paintbrush dipped in acetone. The fabrications were left to cure for two days.

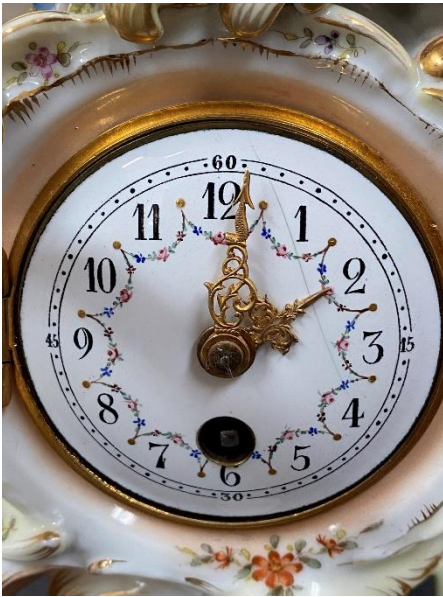
Figure 4 - Detail of clock face

A scalpel was used to lightly probe the crack on the enamel clock face. No ledge could be determined, indicating that the crack originates between the metal underlayer and the layers of glass enamel, but not extending to the surface. Epotek 301 was prepared with a small amount of white powdered pigment and applied to the crack on the clock face in an attempt to secure it. However, it did not appear to absorb any adhesive and was removed. Because of the delicate nature of the enamel and decorative flowers, further attempts to repair the face were deemed excessive and not attempted.

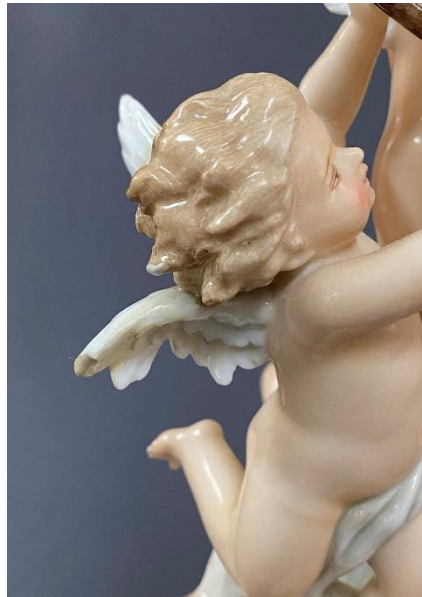
Figure 5 - Detail of old repair on wing

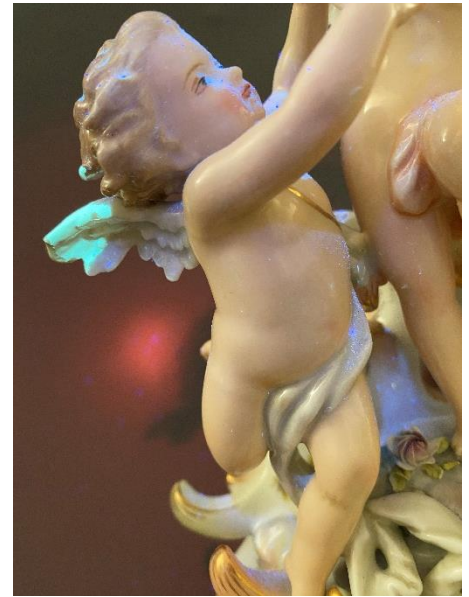
Figure 6 - Detail of old repair under UV

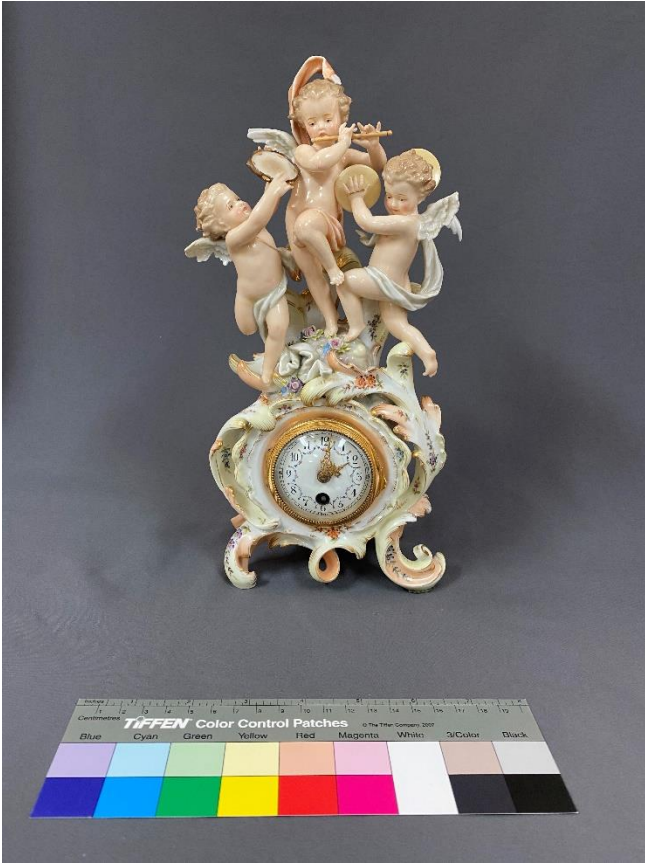
Figure 7 - Clock before treatment

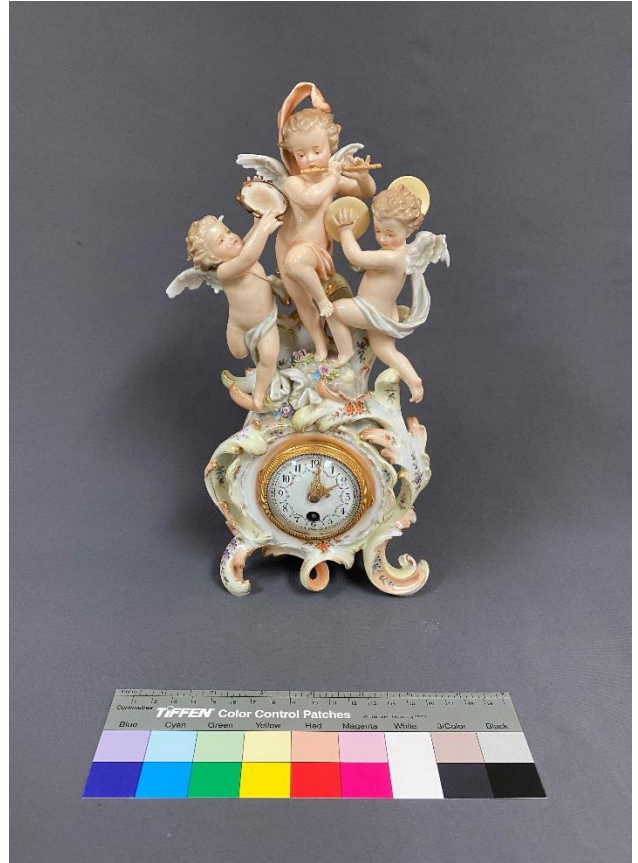
Figure 8 - Clock after treatment

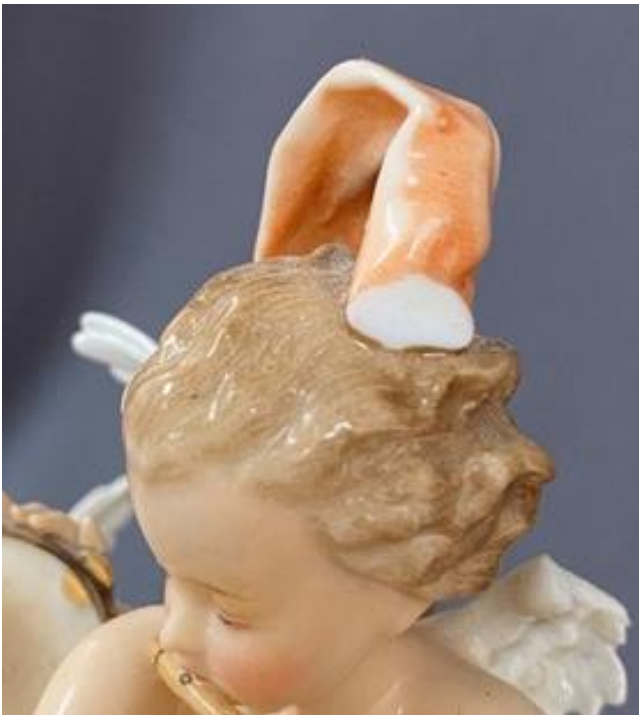
Figure 9 - Detail of ribbon before treatment

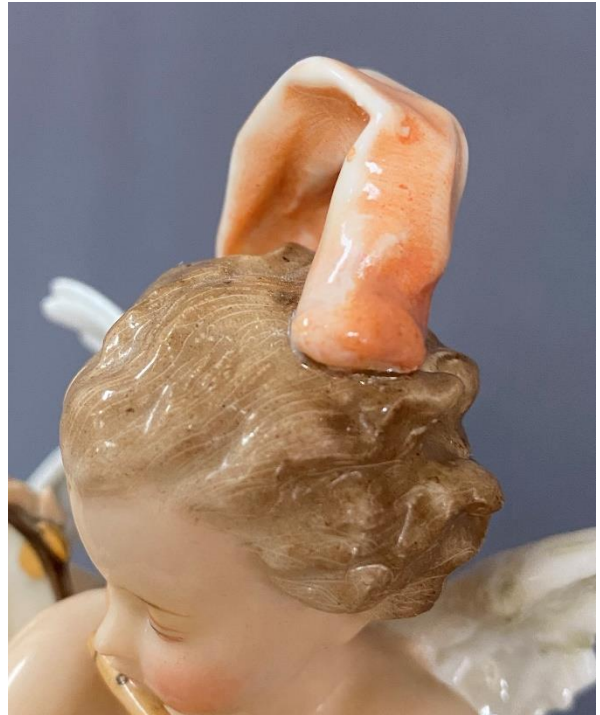
Figure 10 - Detail of ribbon after treatment

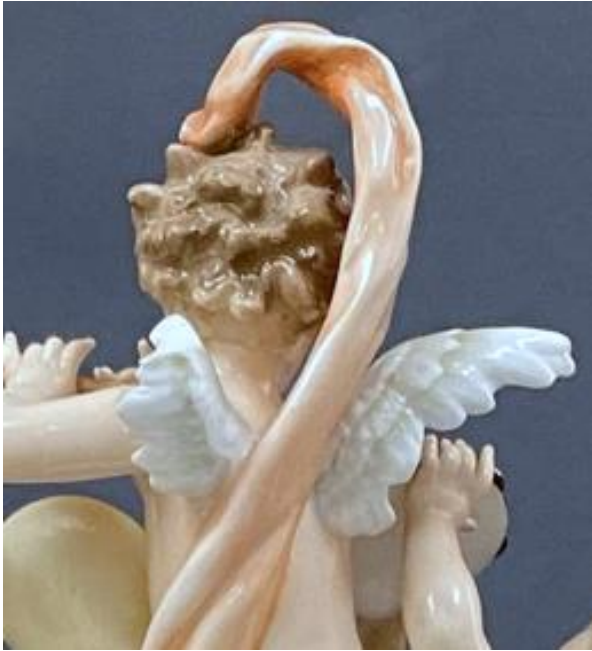
Figure 11 - Detail of top wing before treatment

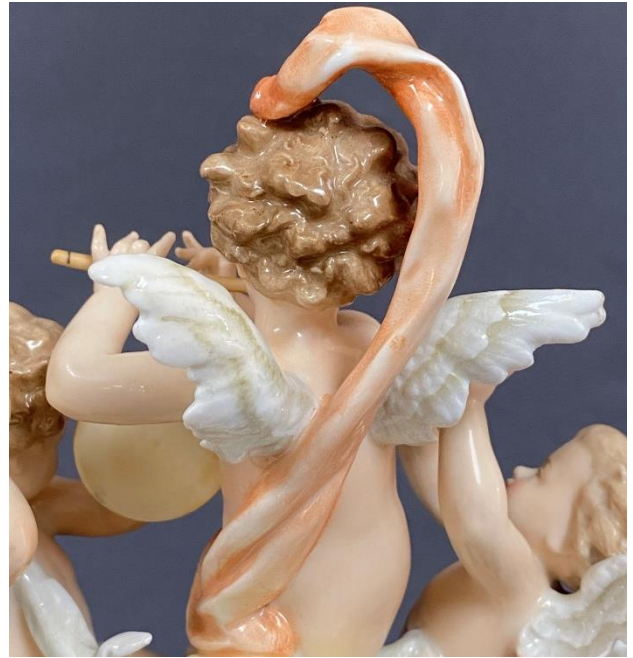
Figure 12 - Detail top wing after treatment

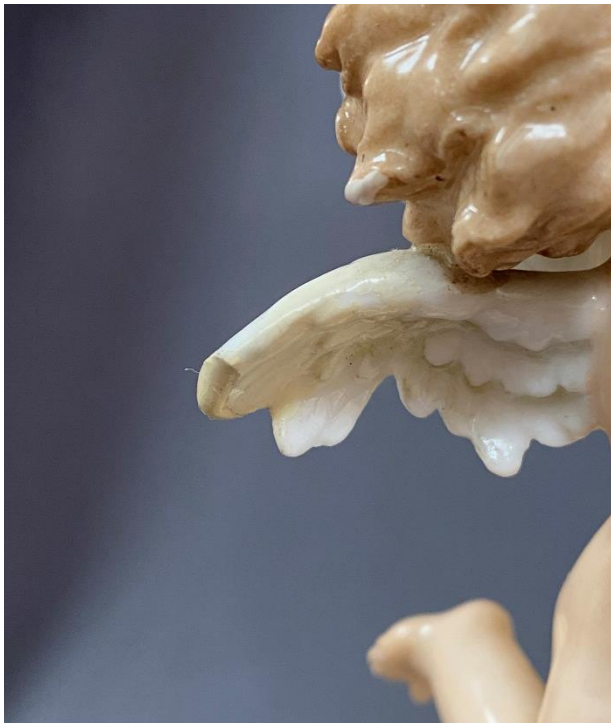
Figure 13 - Detail of lower wing before treatment

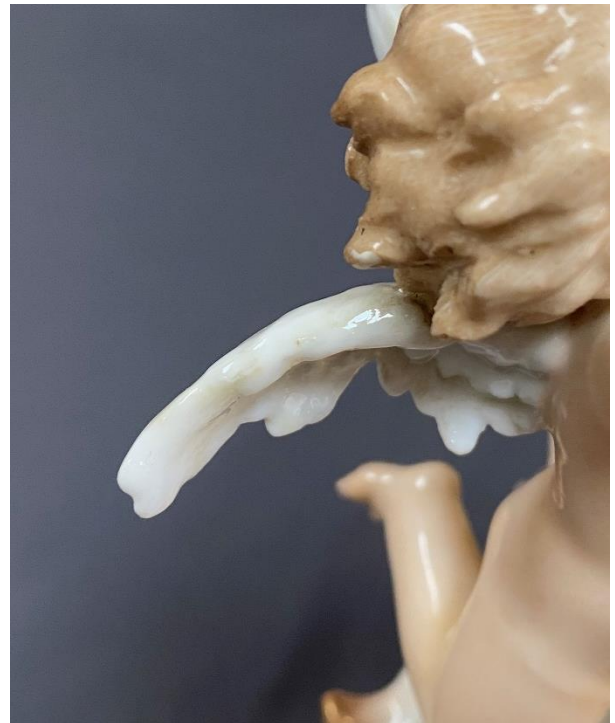
Figure 14 - Detail lower wing after treatment
