Object	Condition and Treatment Report
--------	--------------------------------

2020.2 - Federal Style Mirror

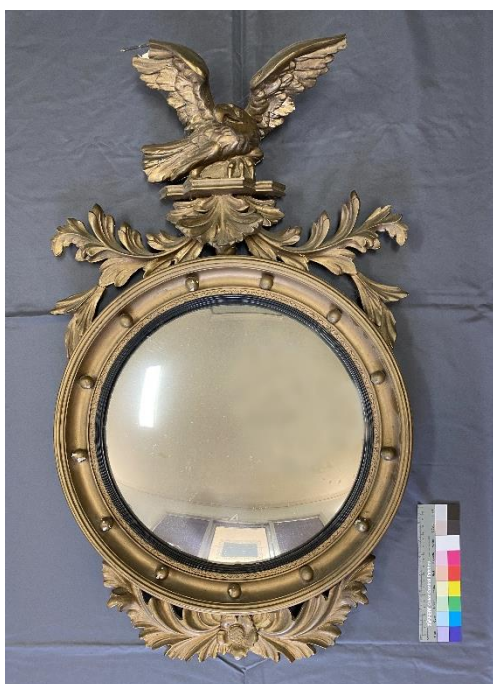
Before

The mirror is in overall good condition. The silvering to the back of the mirror is intact. The frame and mirror are dirty. There are several losses throughout the gilt frame and several stress fractures. The proper right wingtip of the eagle is missing up to 4". There are paint losses to several of the balls to the interior of the round frame. There is a missing section to a floret at the bottom of the frame, an area to the left of the floret, and a leaf to the proper right with loss of gesso. The cardboard backing to the mirror has broken into three pieces.
