Conservation of Ceramics

Condition and treatment report

Conservator: Jamie Rigsby	Date allocated 08/10/2018
Object Blue Powder Wilton Ware Plate with Asian Garden Scene	
Treatment start date 22/10/2018	Treatment completion date 01/12/2018

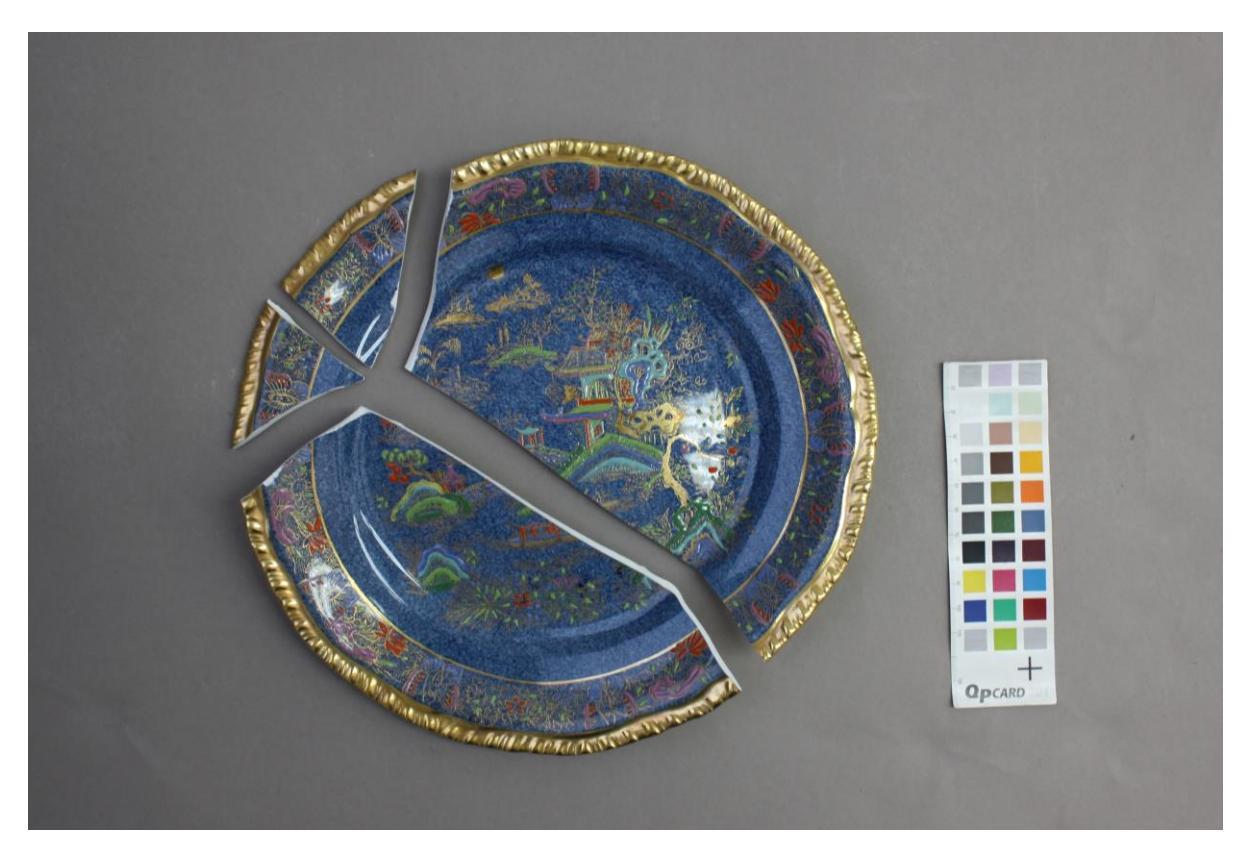
Figure 1, Front of Plate

The plate is broken into four pieces. One long break diagonally bisects the centre of the plate with two smaller pieces at the upper left rim. There is surface dirt with fingerprints and residue to the centre back. The clay fabric is bright white with no visible surface dirt, indicating new breaks. The two larger pieces have a clean break with minimal losses. There is a 1.25cm crack in the glaze on the back of one of the large pieces, but the crack does not

Acetone was brushed along the edges of the plate with a sable brush to slow the cure time of the Paraloid B-72 solution. The 50% B-72 solution in acetone was then applied with a sable brush. The pieces were fitted together and secured in place using cellophane tape, but

The tape was removed, and the breaks checked for alignment. The reconstruction was successful, and the breaks showed no indication of slipping or misalignment. Flügger was used to fill the losses to the plate and was applied with a spatula. The fills to the front of the plate were not tinted before application because the area would require many different colours to match the mottled blue background of the plate. However, the fills to the back of the plate as they would require less retouching. The fills were allowed to cure for several days. Additional Flügger was added to low areas and allowed to cure for several more days. The fills were then smoothed with Micromesh⁵ 2400-12000 grit. The fills were retouched with a sable brush and Golden Acrylic paint and varnish. See Figure 5 and 6 below for after treatment photographs.

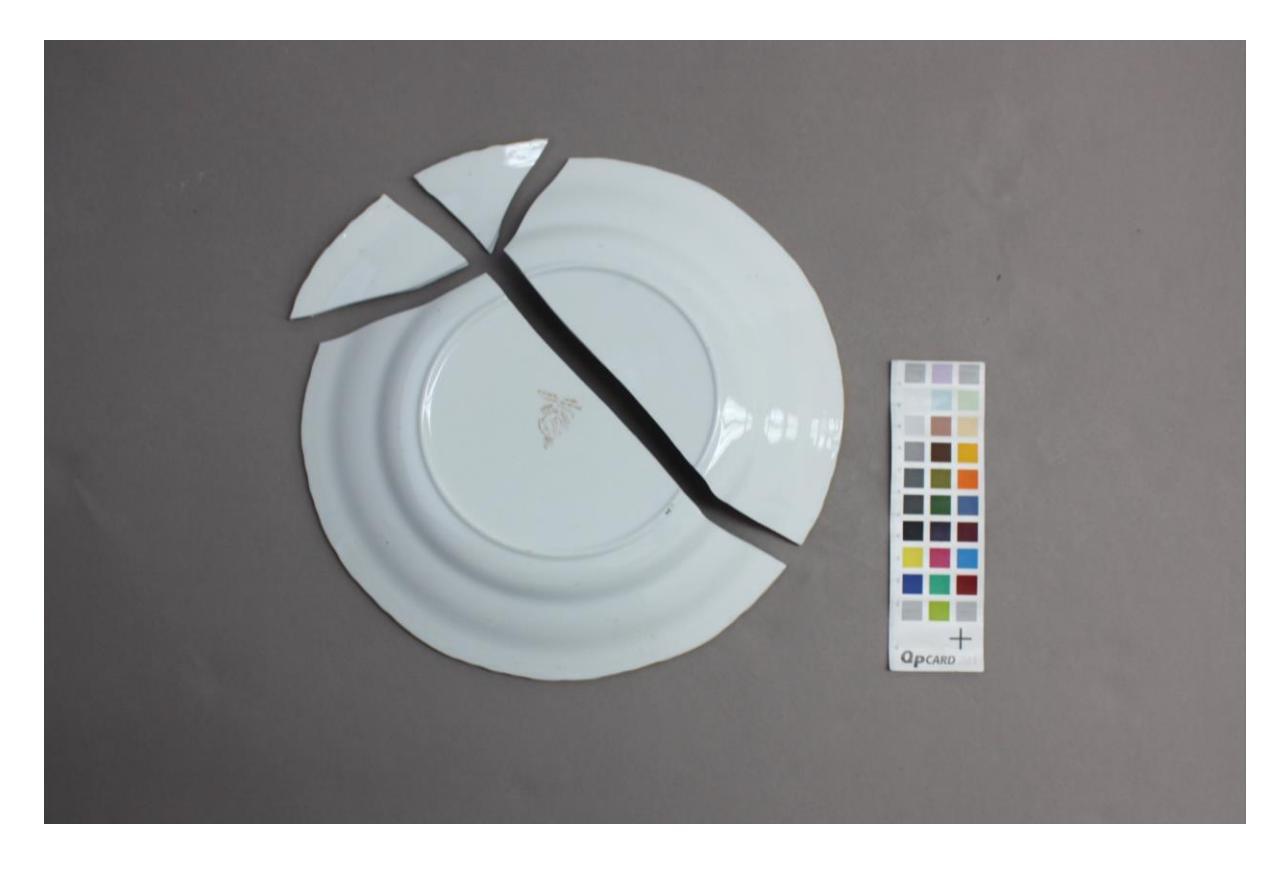
Figure 2, Verso of plate

appear to go through the body or the front glaze. The two rim pieces have more losses along the front of the break edges in the blue powder glaze (Figure 4), but almost none to the back. The pieces appear to fit together well with no torsion.

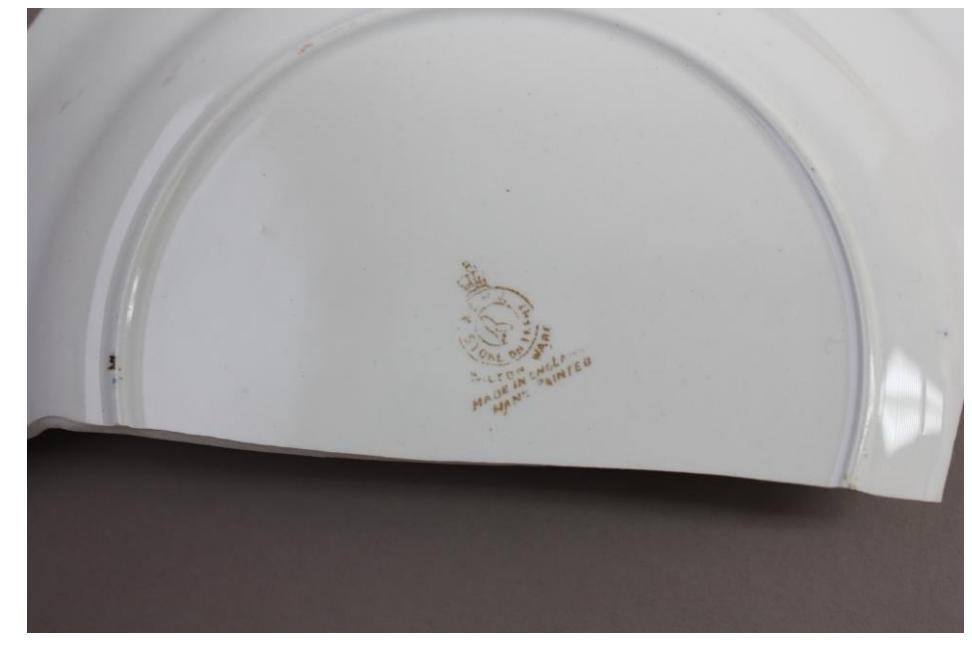
The mark, on the centre back of the plate, is stamped in an ochre colour. The upper part of the mark is obscured but is believed to be 'A. G. H. J.,' for A. G. Harley Jones. The words 'Stoke-on-Trent,' 'Wilton Ware,' and 'Painted by Hand' can be seen (Figure 3).
